DEPARTMENT OF TRANSPORTATION**DIVISION OF ENGINEERING SERVICES**

Quality Assurance and Source Inspection

Contract #: 04-0120F4Cty: SF/ALA Rte: 80 PM: 13.2/13.9File #: 1.28**WELDING INSPECTION REPORT****Resident Engineer:**Siegenthaler, Peter**Address:** 333 Burma Road**City:** Oakland, CA 94607**Report No:** WIR-021716**Date Inspected:** 08-Mar-2011**Project Name:** SAS Superstructure**OSM Arrival Time:** 700**Prime Contractor:** American Bridge/Fluor Enterprises, a JV**OSM Departure Time:** 1730**Contractor:** American Bridge/Fluor Enterprises, a JV**Location:** Job Site**CWI Name:** Fred Von Hoff**CWI Present:** Yes No**Inspected CWI report:** Yes No N/A**Rod Oven in Use:** Yes No N/A**Electrode to specification:** Yes No N/A**Weld Procedures Followed:** Yes No N/A**Qualified Welders:** Yes No N/A**Verified Joint Fit-up:** Yes No N/A**Approved Drawings:** Yes No N/A**Approved WPS:** Yes No N/A**Delayed / Cancelled:** Yes No N/A**Bridge No:** 34-0006**Component:** Tower Grillage**Summary of Items Observed:**

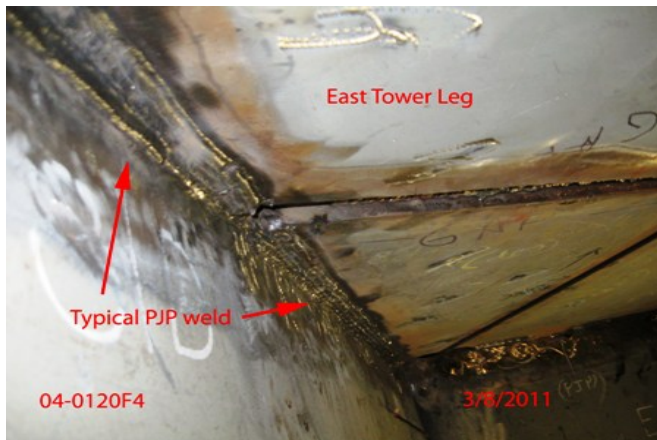
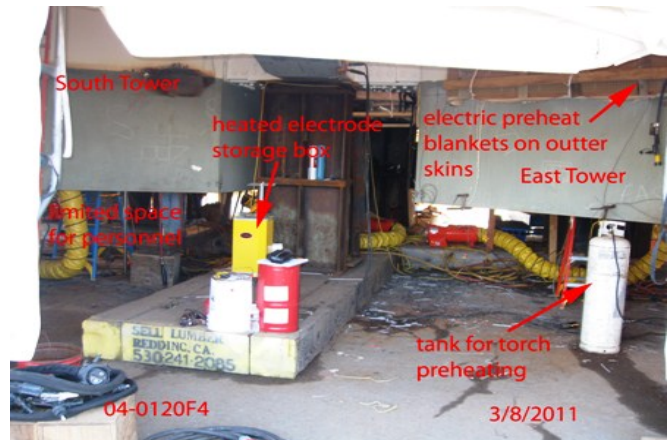
The welding/work observed this date appeared to comply with the contract requirements. See photos below showing the limited space for welding personnel, QC personnel and QA personnel. See photos below.
